Manhole Inspection Summary

Manhole # S03EE2010MH

Insp Date: **7/20/06 9:04 AM**

Location Address: **2934 VERDENE AVE**

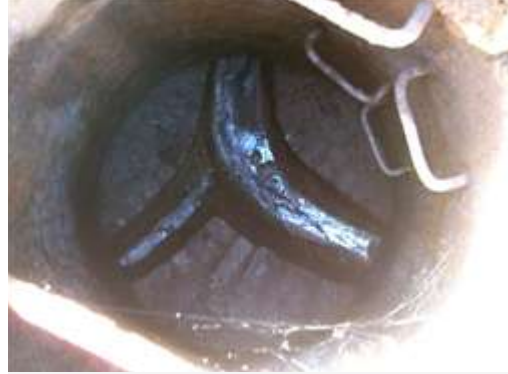
Top View

Bench and Channel debris.

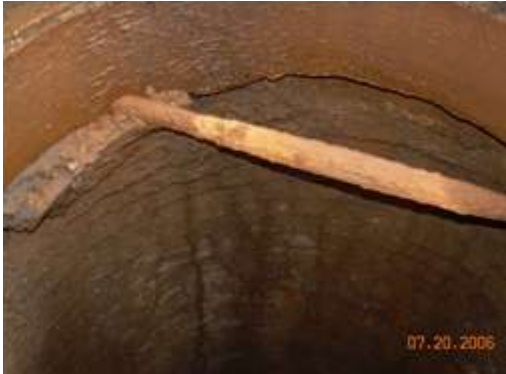
Defect

Frame leaks. Adjustment deterioration and infiltration.

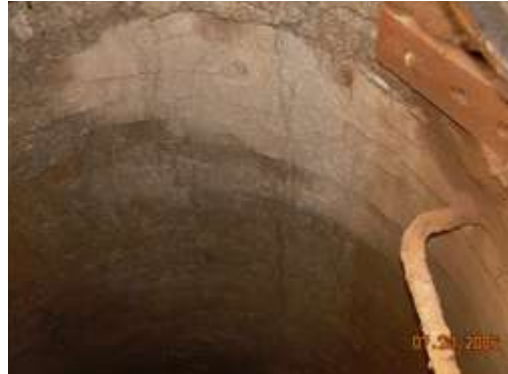
Defect

Adjustment deterioration, loose brick and infiltration. Corbel infiltration.

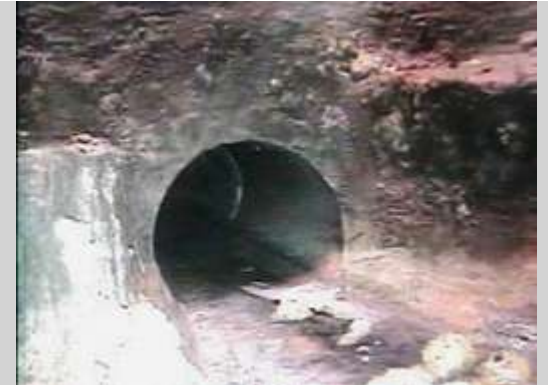
8 in. Circular Gravity Sewer Pipe Out @ 12 O'Clock

Deposits: ☐ None ☒ **Mud** ☐ Sludge ☒ **Debris** ☐ Grease

Silt Depth: **0** (in.) Deposits Extent: **Light**

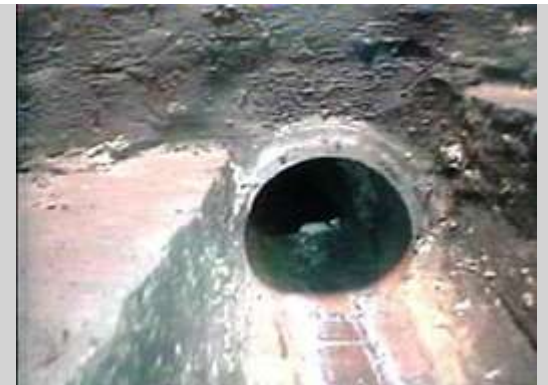
8 in. Circular Gravity Sewer Pipe In @ 4 O'Clock

Deposits: ☐ None ☒ **Mud** ☐ Sludge ☒ **Debris** ☒ **Grease**

Silt Depth: **0** (in.) Deposits Extent: **Light**

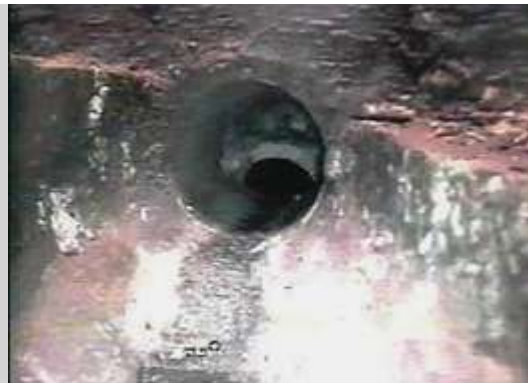
Pipe In @ 7 O'Clock

Comments **Has a lock and bar. The I7 has an extrem offset joint.**

Offset joint.
